GROUP Transmission	MODEL 2020MY~ Soul (SK3)
	NUMBER PS605	DATE April 2019

DIFFICULT TO SHIFT INTO 1 ST GEAR

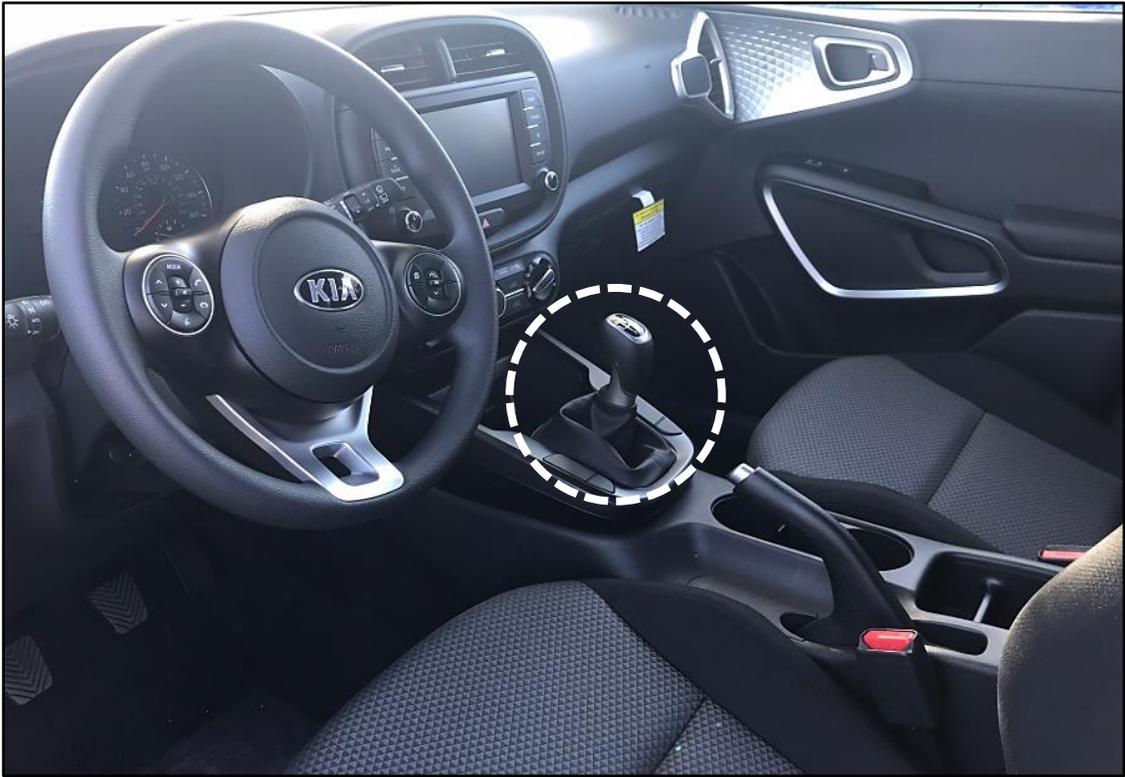
This Pitstop provides information regarding a possible difficult to shift into 1st gear concern on 2020MY Soul (SK3) vehicles equipped with manual transmissions. The possible root cause could be that the shift/control cable is out of adjustment. To correct the concern, refer to KGIS service manual, **Manual Transaxle System → Manual Transaxle Control System → Control Cable → Repair Procedures.**
